# EVALUATING CONCRETE BRIDGE DECK PERFORMANCE

## *Interim Project Report*

While planning the replacement of three bridges on Highway 243 north of Saco, Montana, bridge engineers at the Montana Department of Transportation (MDT) recognized and seized a unique opportunity to evaluate different deck designs built by the same contractor and subsequently exposed to the same environmental and vehicular conditions. Thus, variability in test articles and conditions between test sites typically encountered in large-scale field investigations was minimized in this situation. The primary focus of this research project has been to compare the performance of three different bridge deck designs.

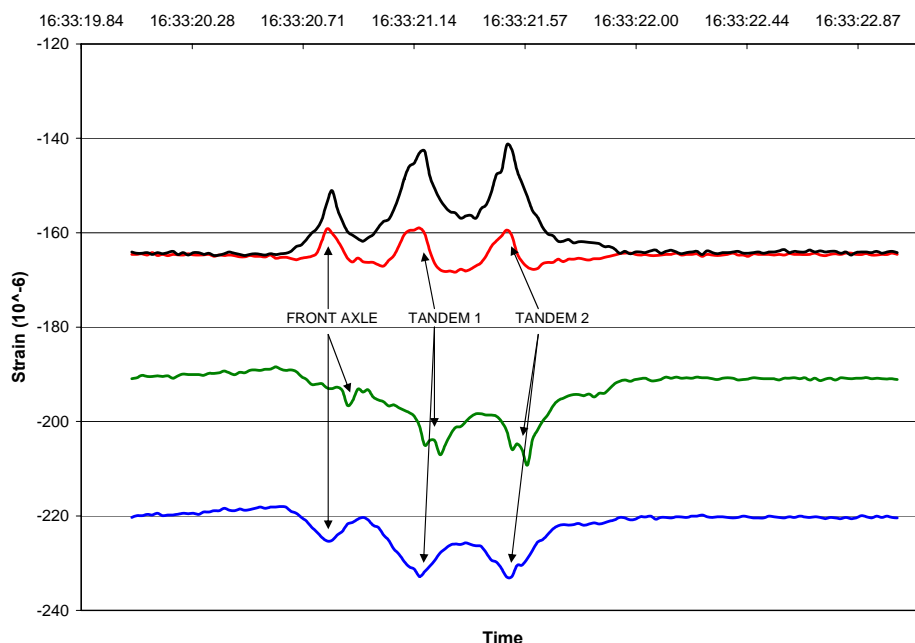
**Figure 65: Typical Strain Response during a Large Vehicle Event**

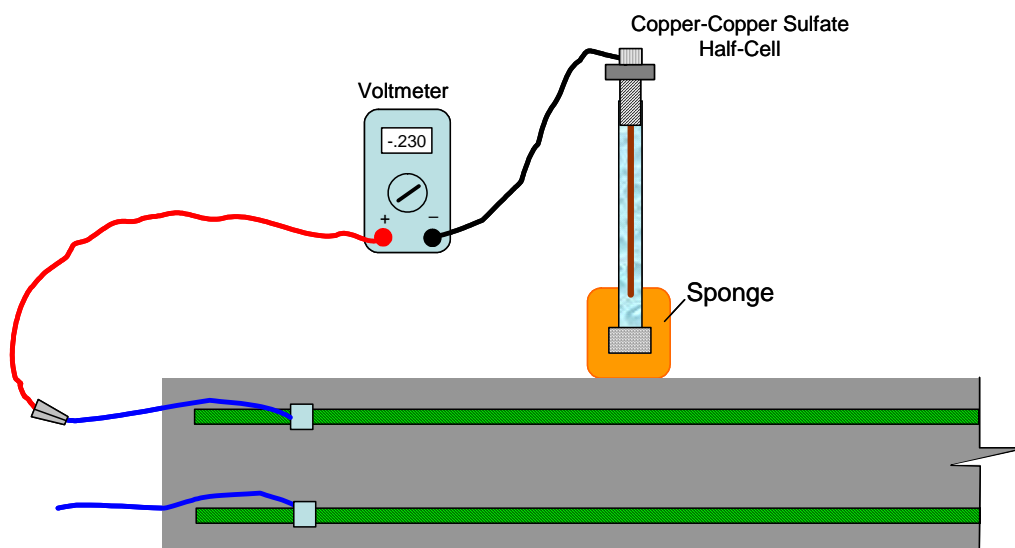
**Figure 66: Illustration of Half-Cell Test on Saco Bridges**

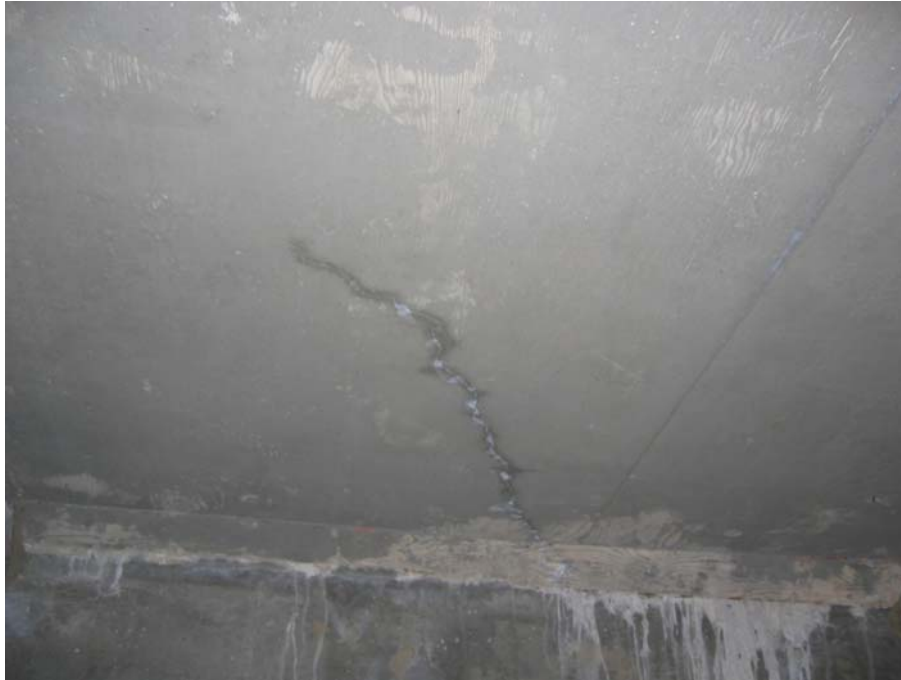
**Figure 67: Full-Depth Crack in Empirical Deck as Seen from Underside**

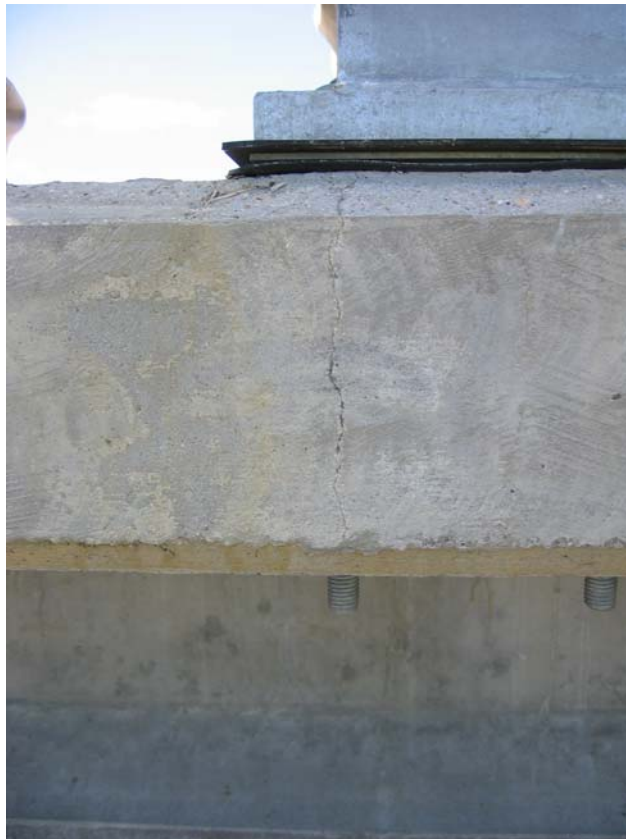
**Figure 68: Cracks in the Overhang of the HPC Deck**

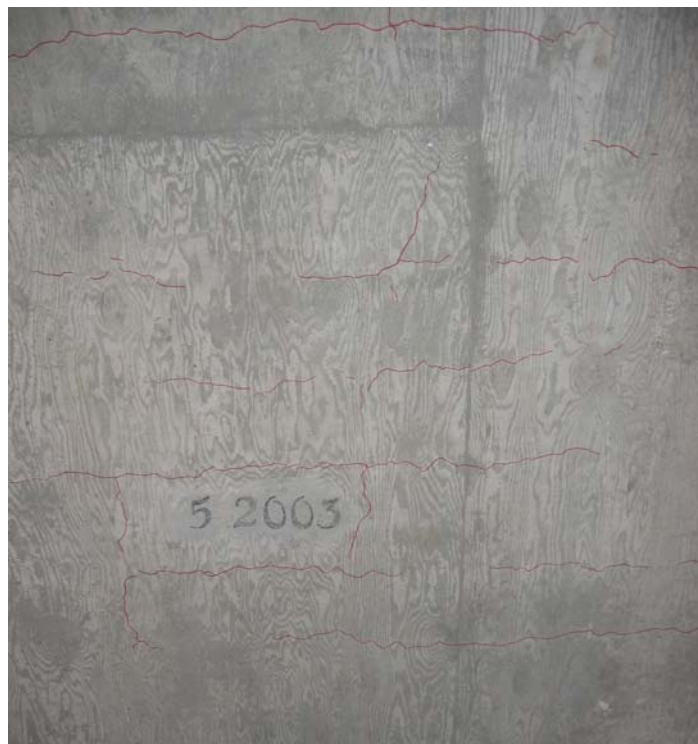
**Figure 69: Surface Cracks on the Bottom of the HPC Deck**

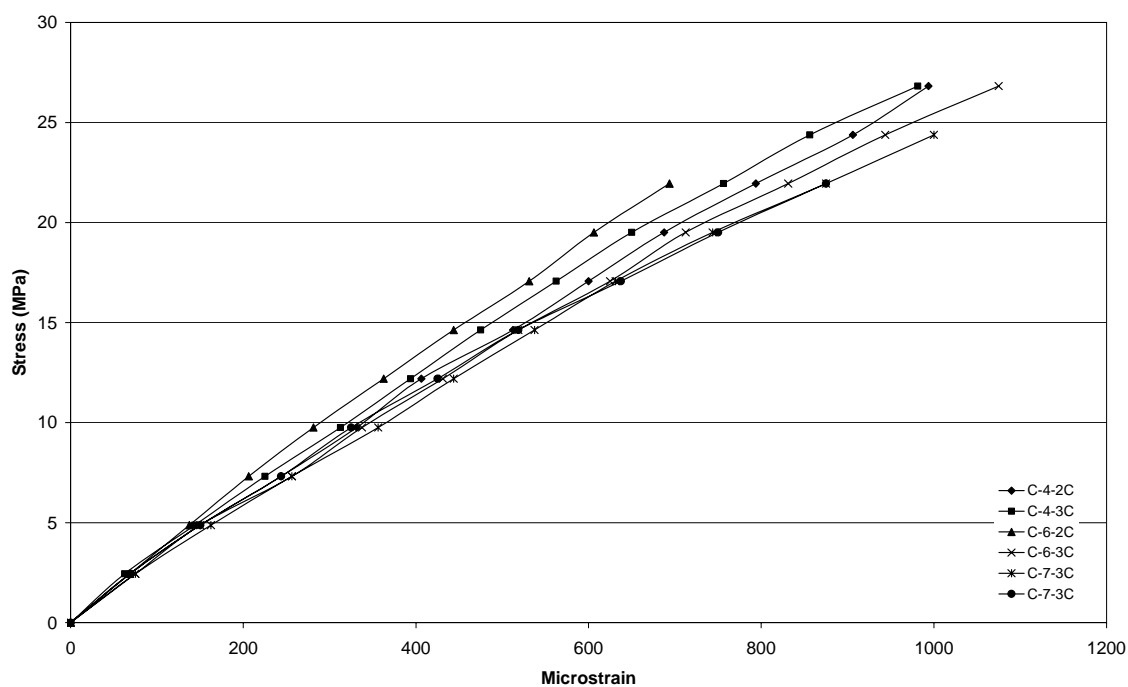
**Figure A-1: Concrete Stress/Strain Plots for the Conventional Bridge Deck (28-Day)**

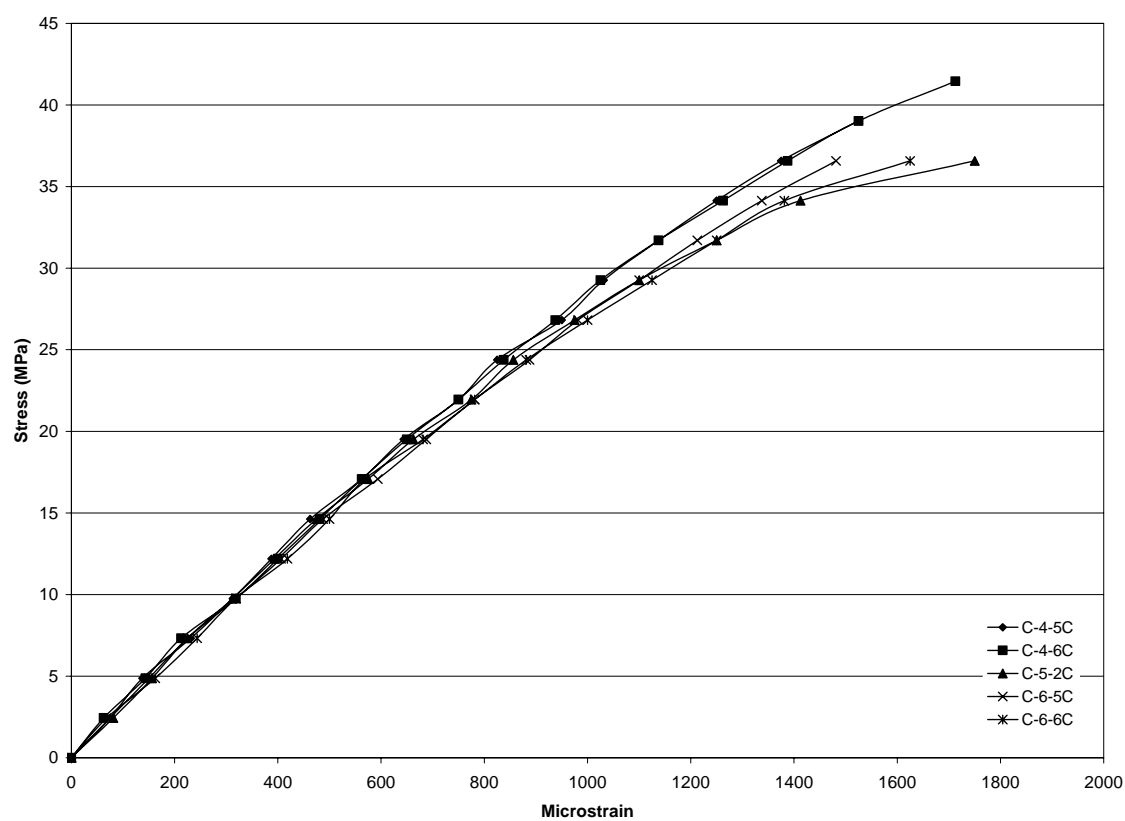
**Figure A-2: Concrete Stress/Strain Plots for the Conventional Bridge Deck (Live-Load 1)**

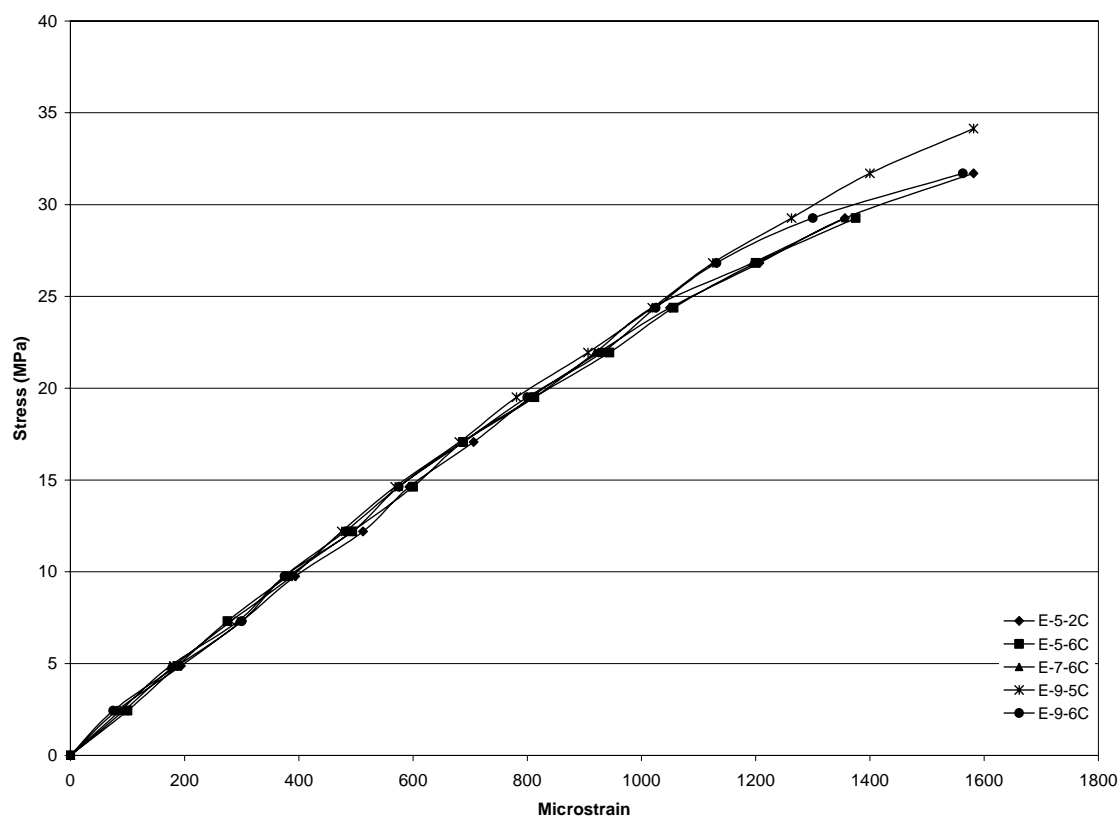
**Figure A-4: Concrete Stress/Strain Plots for the Empirical Bridge Deck (Live-Load 1)**

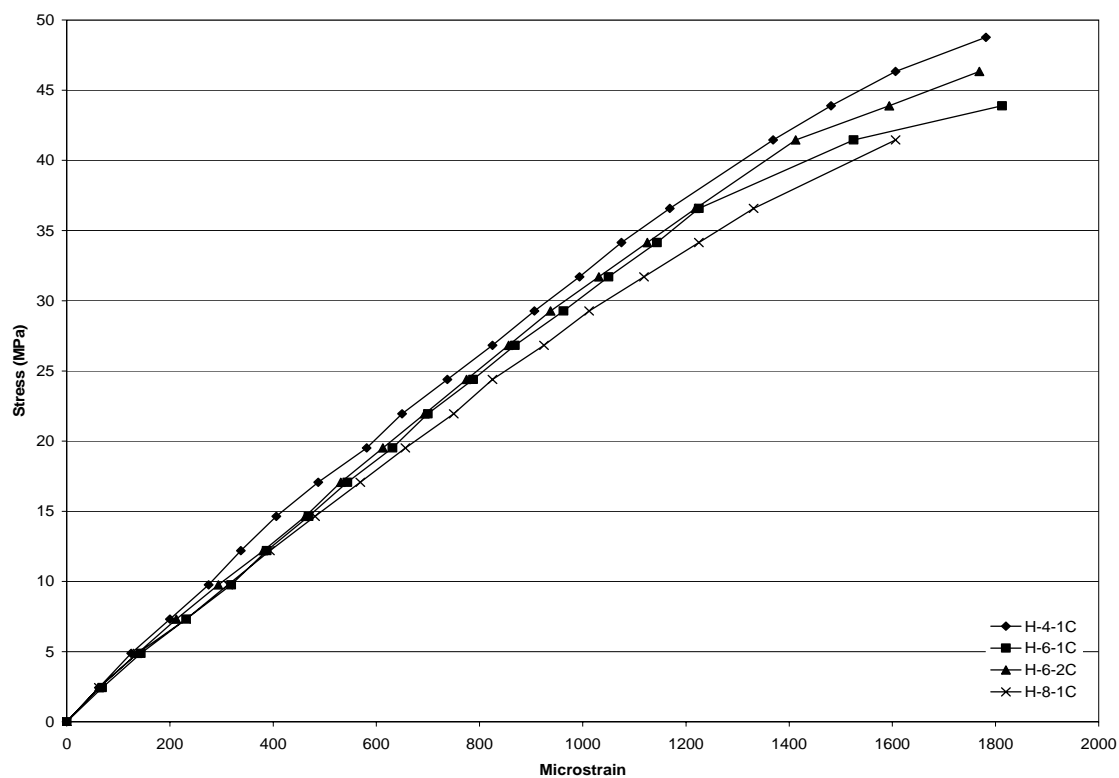
Figure A-5: Concrete Stress/Strain Plots for the HPC Bridge Deck (28-Day)

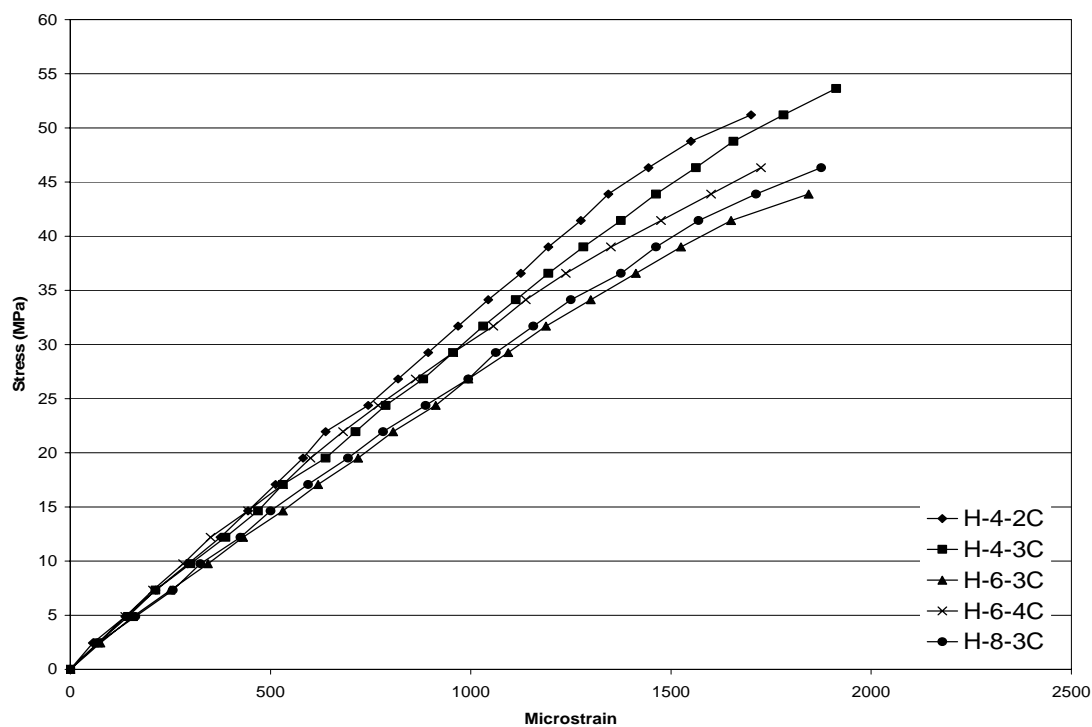
Figure A-6: Concrete Stress/Strain Plots for the HPC Bridge Deck (Live-Load 1)

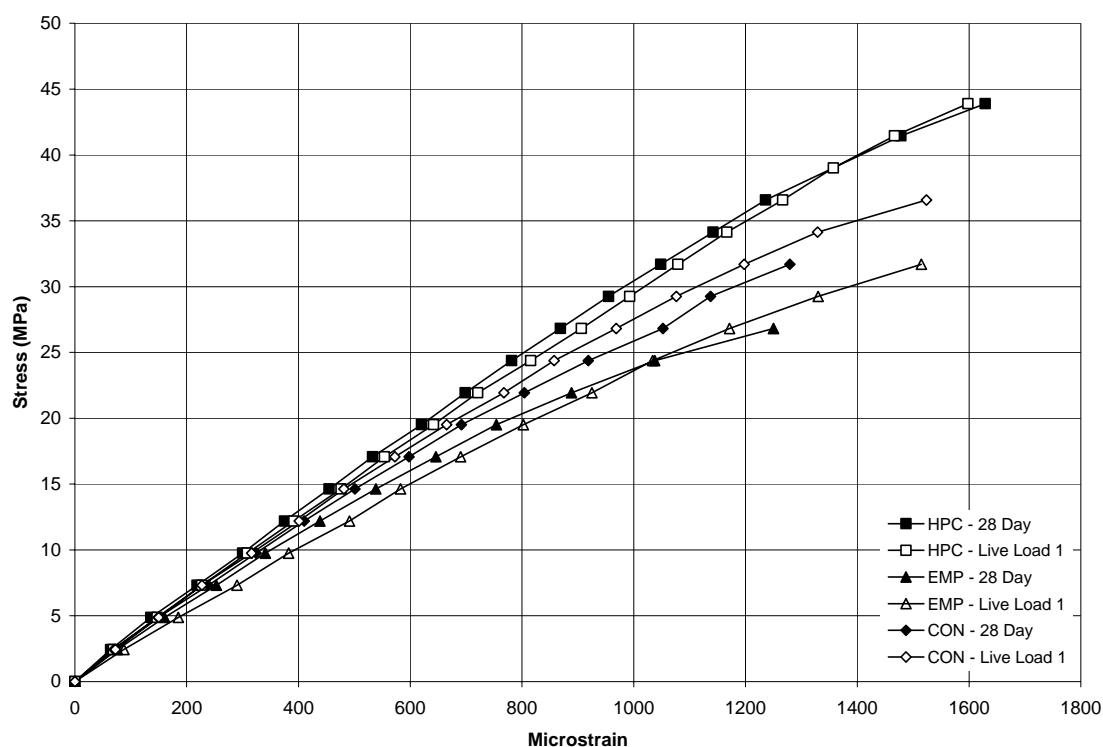
Figure A-7: Average Stress/Strain Plots for All Bridge Decks

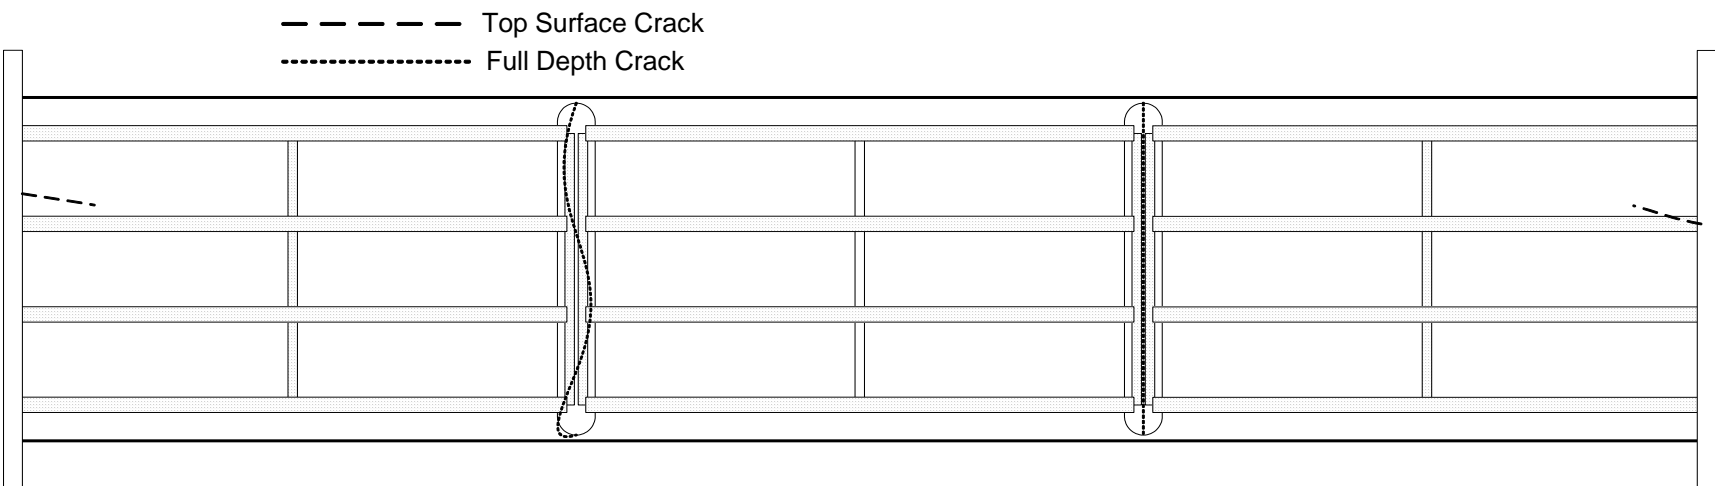
Figure F-3: Detailed Map of Crack Survey on the HPC Bridge Deck
